1 Causes of defects associated with tolerances in construction: A case study

18 Abstract

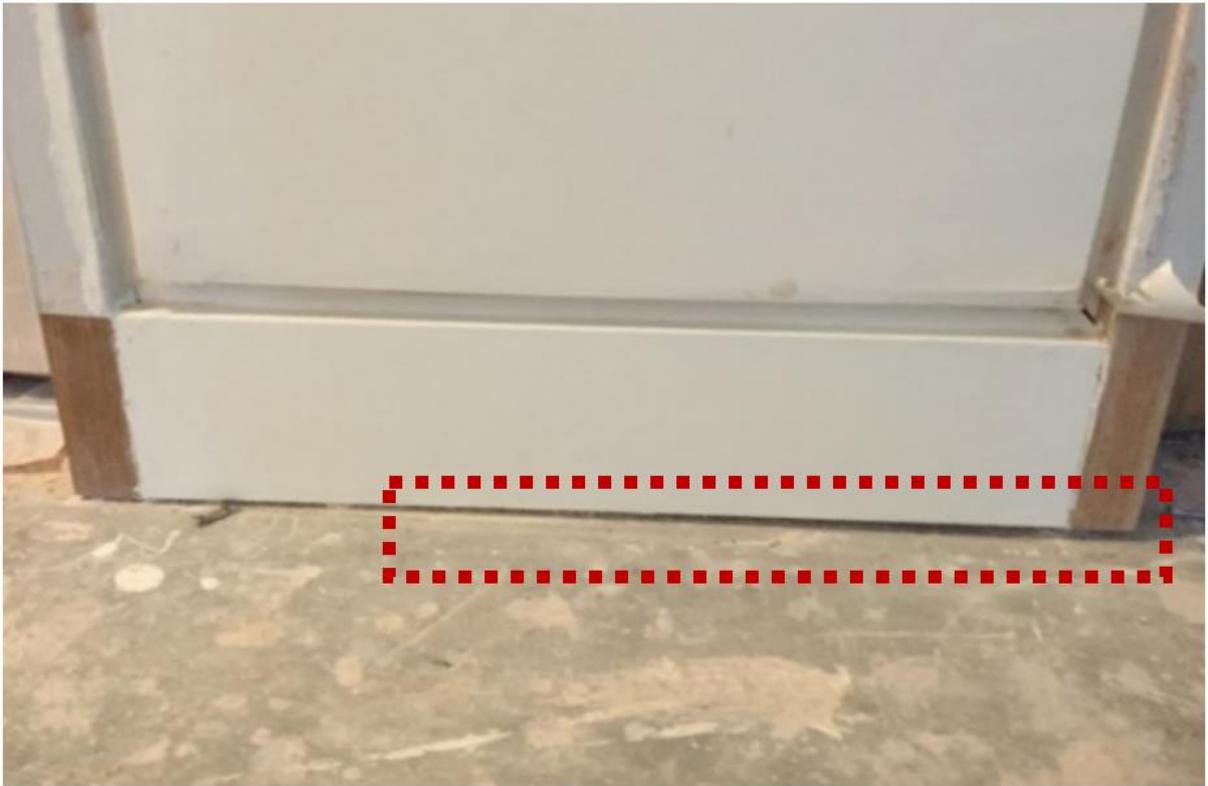
813 Figure 1

300 **Fig. 1.** Excessive gap between the skirting and the concrete slab.

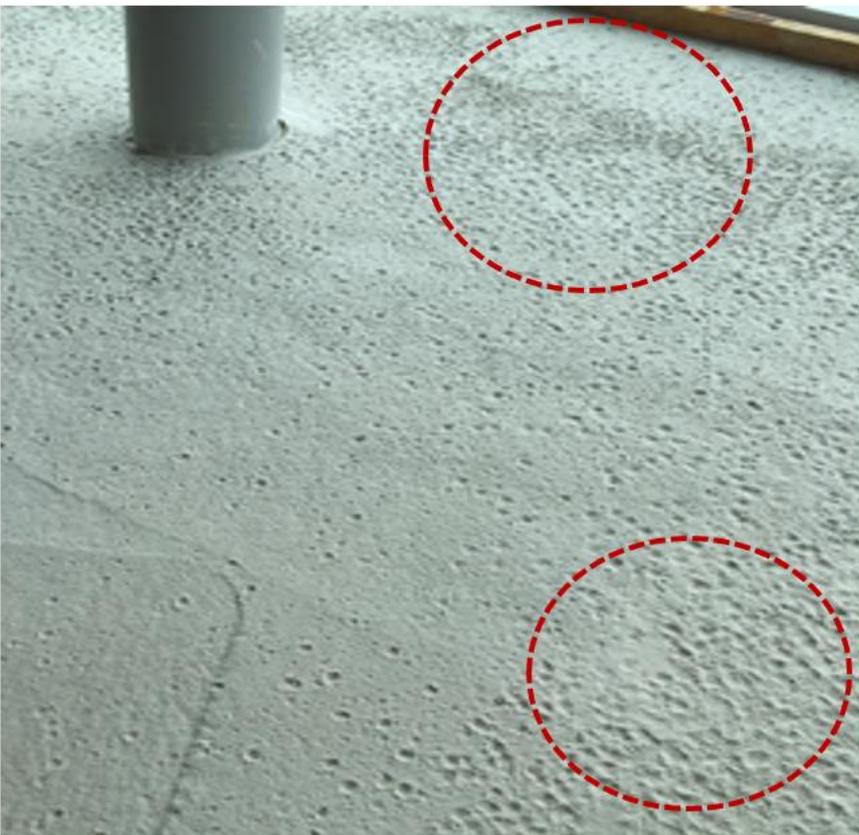
815 Figure 2

302 The concrete subcontractor had to stop working in the evenings when pouring upper floors
303 due to complaints from residents living around the site to the Environment Agency of the
304 Local Authority and could not use the power float when it started to rain (Interviewees 1, 7).
305 Rain as an *environmental condition* (Interviews 6, 8) and people's complaints as an
306 *unforeseen special cause* (Interviewees 2, 8) "made it difficult for the concrete subcontractor
307 to achieve the required [flatness tolerances in] surfaces" (Interviewee 8) (Figure 2).

308 **Fig. 2.** Flatness of concrete slabs affected by special issues.

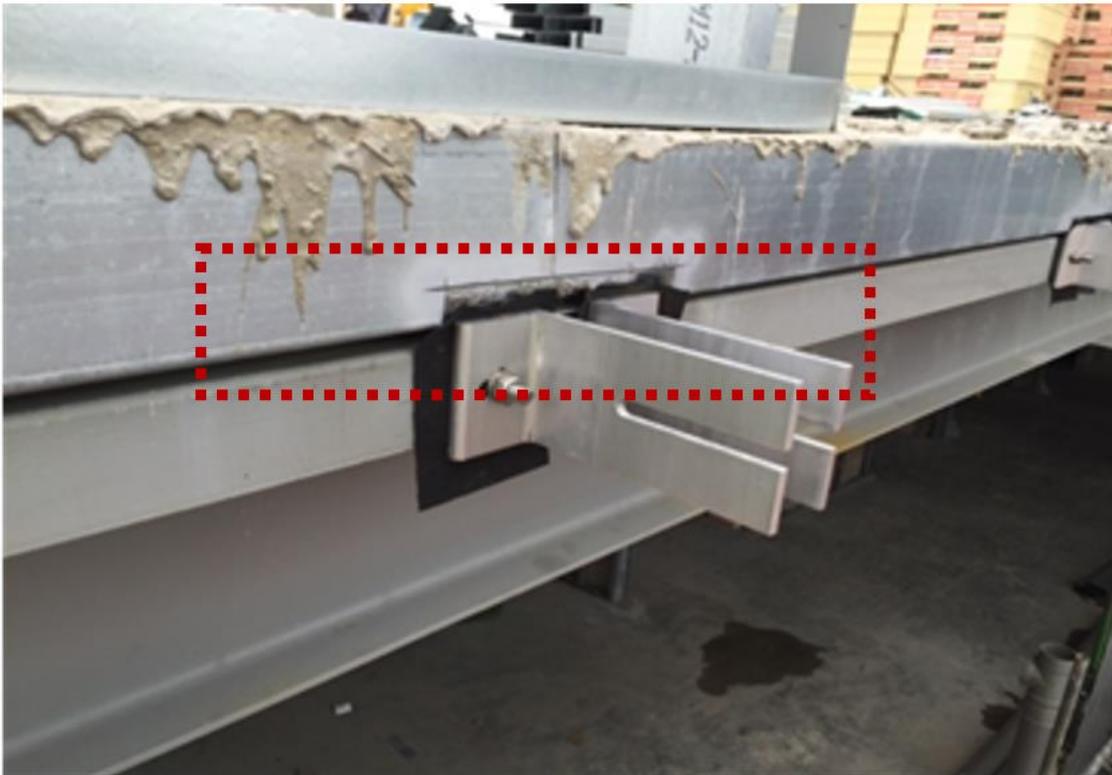
818 Figure 3

329 **Fig. 3.** Modified edge of the concrete slab.

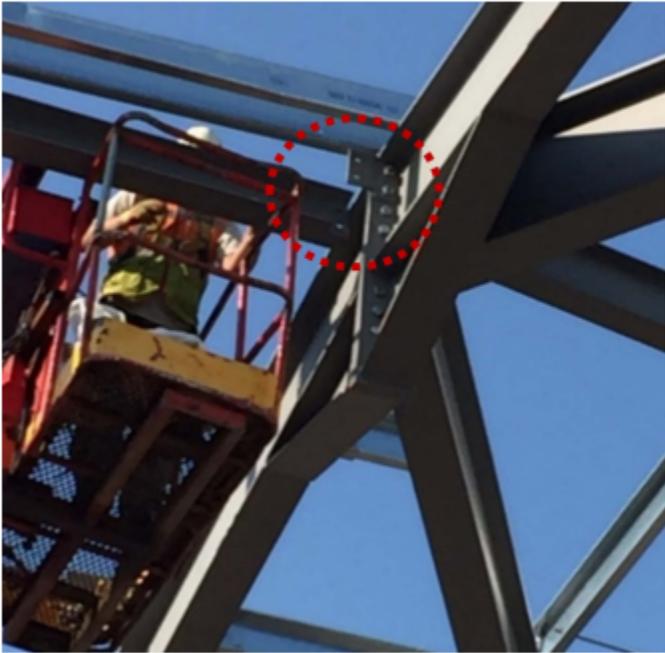
Fig. 9 Lack of fit of the beam between two grid lines
