1 Causes of defects associated with tolerances in construction: A case study

18 Abstract

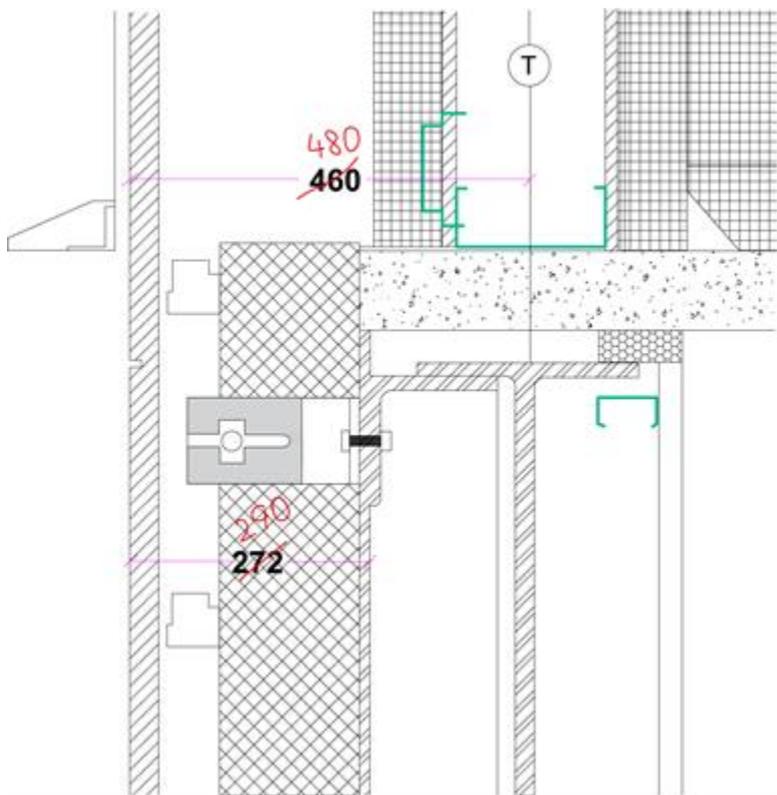
818 Figure 3

327 permitted from the surface of the steel beam, the bracket could not be installed without
328 cutting the edge of the slab (Interviewees 1, 8, 9) (Figure 3).

329 **Fig. 3.** Modified edge of the concrete slab.

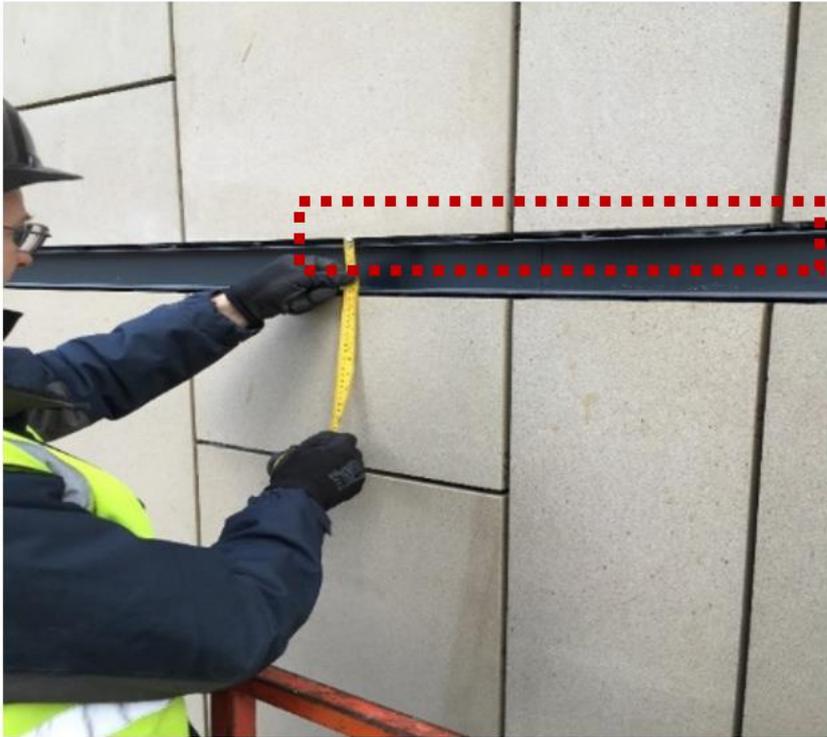
820 Figure 4

331 The Steel Framing Systems (SFS) studs were out of plumb (Figure 4). “None of the Quality
332 Check Sheets included information about the permissible deviations of the plumbness of the
333 SFS studs” (Interviewee 1), or “how and when they should be measured” (Interviewee 1). As
334 a result, the tolerance problem with the SFS studs was recognised after they were handed
335 over by the cladding subcontractor (Interviewee 7), when “they started to build their system
336 on the SFS studs” (Interviewee 7). Thus, this problem was due to *ineffective quality control*
337 *documents*. Also, Interviewee 4 says that given “the operatives had to complete their work as
338 quickly as possible, they were not that much concerned about the quality of their work”.
339 Hence, *poor workmanship* was another cause behind this tolerance issue.

341 The cladding subcontractor developed a design in which the offset from the steelwork to the
342 face of the stone panels was 272 mm. In this case, the cladding system could absorb 32 mm
343 of deviations due to the inclination of steel columns and stone panels. The Architect later
344 increased the offset to 290 mm (Interviewees 1, 2, 6, 8) (Figure 4). This was to accommodate
345 the installation between the steelwork and cladding. “There was *miscommunication* between
346 the architect and the cladding subcontractor about the required distance from the steel to the
347 face of the stone panels” (Interviewee 2). The subcontractor’s input was delayed
348 (Interviewees 1), and “the architect was not convinced to change the design” (Interviewee 1)
349 as “the connection type between the steelwork and cladding system had been designed”
350 (Interviewee 5). Later during construction, “the architect, structural engineer, steel

359 **Fig. 4.** Excessive perpendicularity variations of columns and stone panels.

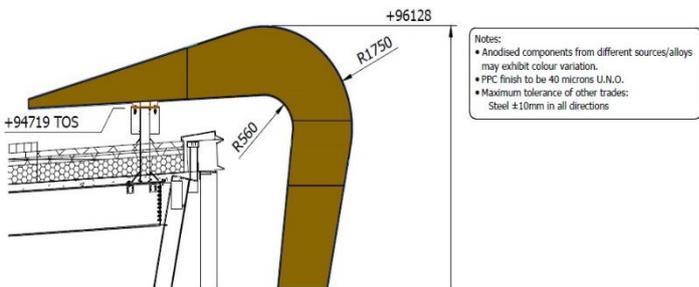
822 Figure 5

361 When the cladding subcontractor put the stone panels on and the dead load was applied to the
362 steel frame, the stone panels started to sag. This meant that the cladding did not stay at the
363 correct level and, in general, everything was sinking downwards. It was noticeable that the
364 gap between the channel and the stone panel in some areas were bigger and the gap was not
365 consistent all the way through (Figure 5). There was *miscommunication* between the

375 **Fig. 5.** Inconsistent gaps in some areas between the channel and the stone panel.

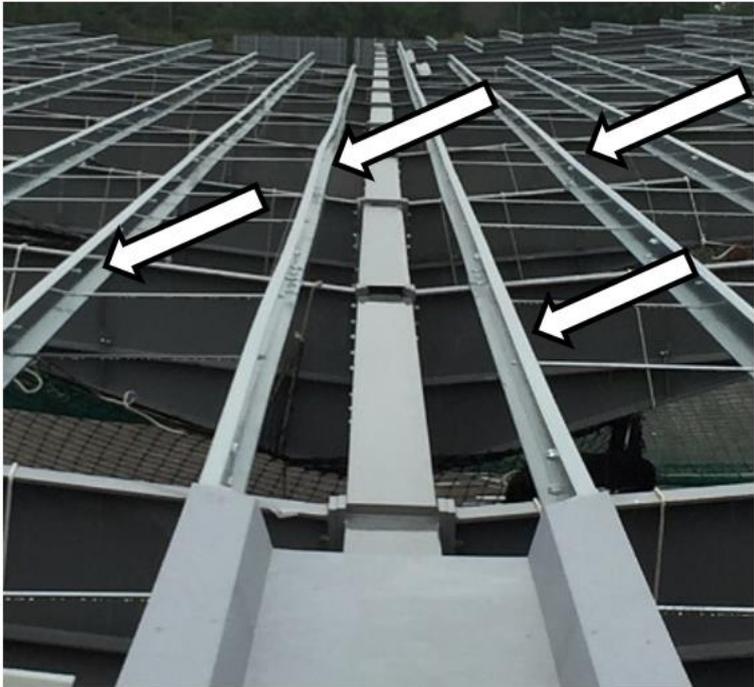
834 Figure 7

402 (Interviewees 10, 12, 14). Moreover, the structural designer had tried to use steel and
403 ancillaries as little as possible (Interviewee 13). The two sides of the doorways were “neither
404 connected to each other nor [were] they ... fixed to the ground” (Interviewee 11), that is, they
405 are free standing. The *inconsistency between a tolerance requirement* (i.e. fitting the shutter
406 door without any rework) *and its budget* led to a situation that by aligning one side of a
407 cladding rail, the other side was becoming out of alignment (Interviewees 10-12) (Figure 7).
408 This inconsistency was to cut down the project costs but resulted in a tolerance issue
409 (Interviewee 14). “Setting a datum to either side of the doorway could have helped the people
410 on site to install the columns right in the first try” (Interviewee 11). This could also have
411 assisted the site engineer to align the columns easier (Interviewees 11) (i.e. *poor datum*

415 **Fig. 7.** Misalignment of stanchions.
